Asbestos Inspection Report

1 Magnox Drive
Pulaski, Virginia

Asbestos & Lead Inspection Report

1 Magnox Drive
Pulaski, Virginia
(Lead – Entire Facility Asbestos – Rear of Facility)

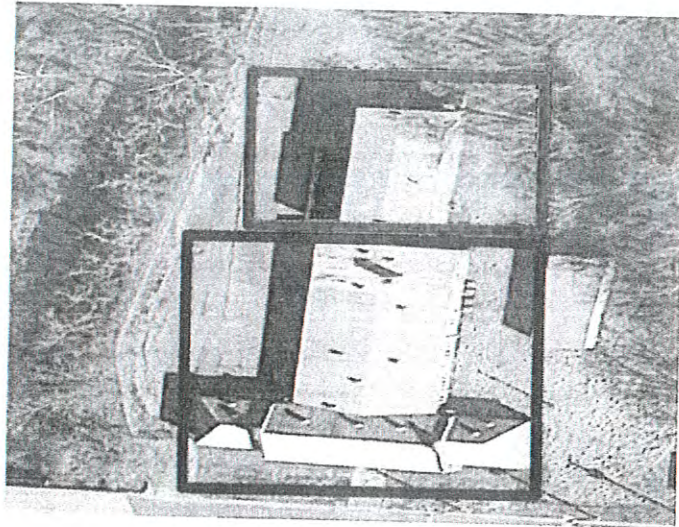
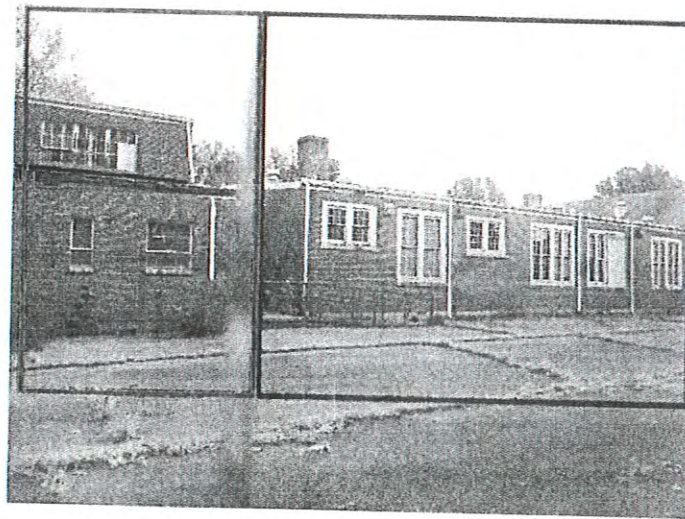
Only the section indicated by the green box above was surveyed.
This report does not include the portion of the building inside the
red box.

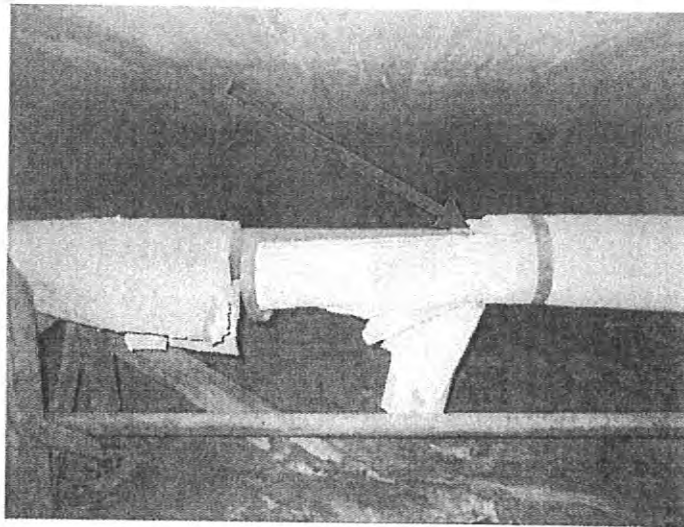
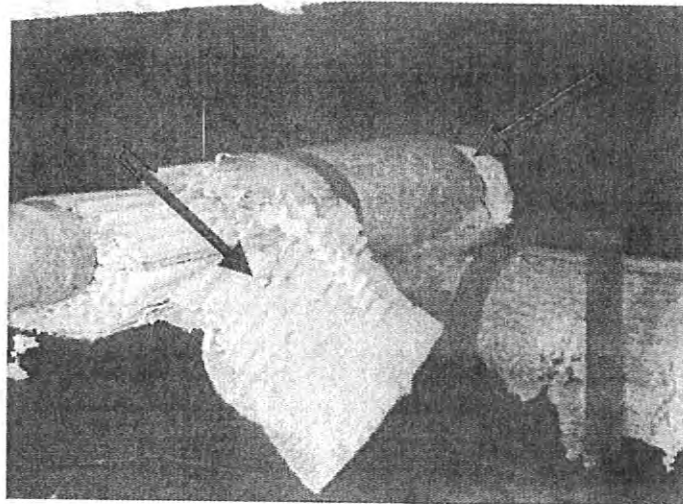
- **AirCell Pipe Insulation located in the crawlspace. This material may also be found inside walls and in chases.**
 - **THIS MATERIAL IS FRIABLE**
 - **THIS MATERIAL IS A HIGH CONTENT ACM**
- **Mudded Elbow Insulation located in the crawlspace. This material may also be found inside walls and in chases.**
 - **THIS MATERIAL IS FRIABLE**
 - **THIS MATERIAL IS A HIGH CONTENT ACM**

The Thermal System Insulation, located in the crawl space of the building, was found to be Asbestos Containing by the laboratory. This includes AirCell Pipe Insulation and Mudded Elbow Insulation.

THESE MATERIALS ARE FRIABLE

THESE MATERIALS ARE HIGH CONTENT ACMs.

THESE MATERIALS ARE DAMAGED AND MAY CONTAMINATE THE GROUND IN AREAS WHERE THEY ARE LOCATED.

These NON-Friable / Friable asbestos containing materials should be removed prior to demolition activities at this location. Removal should be performed by licensed, contract personnel using approved methods.

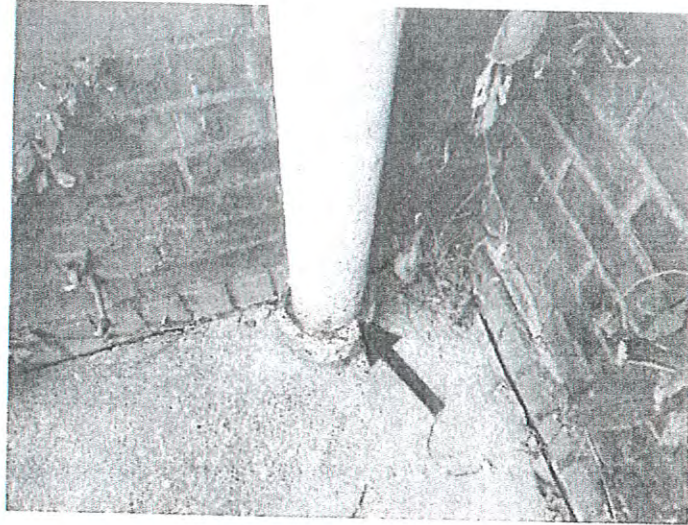
For informational purposes, the gasket indicated above was reported to contain asbestos at $< 1\%$.

The material is a gasket between modern metal downspouts and cast iron downspouts.

Although not considered an Asbestos Containing Material ($> 1\%$), this information should be provided to all contract personnel prior to restoration/demolition activities for their use in meeting current OSHA requirements pertaining to personnel disturbing this material.

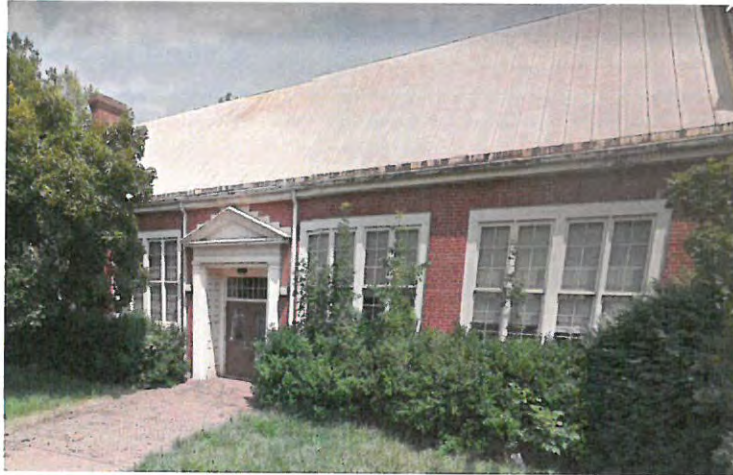
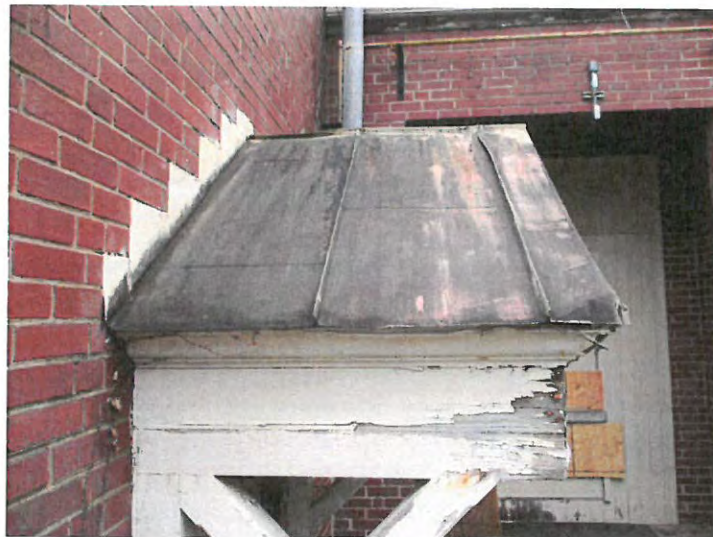
The Coating on the copper roof panels was found to utilize Lead-Based Paint.

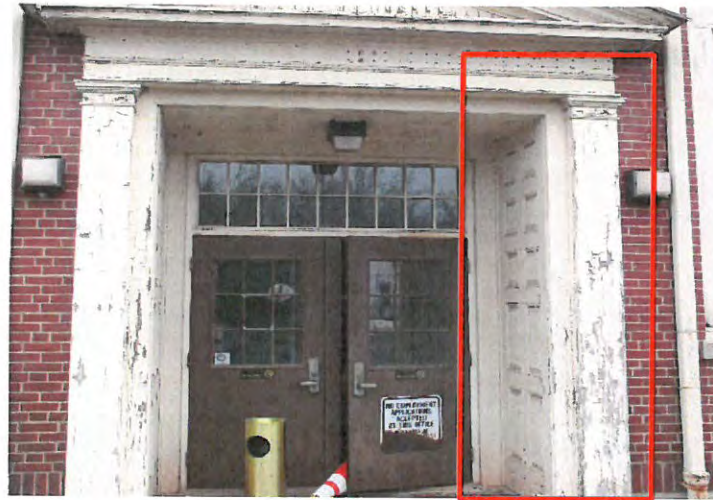
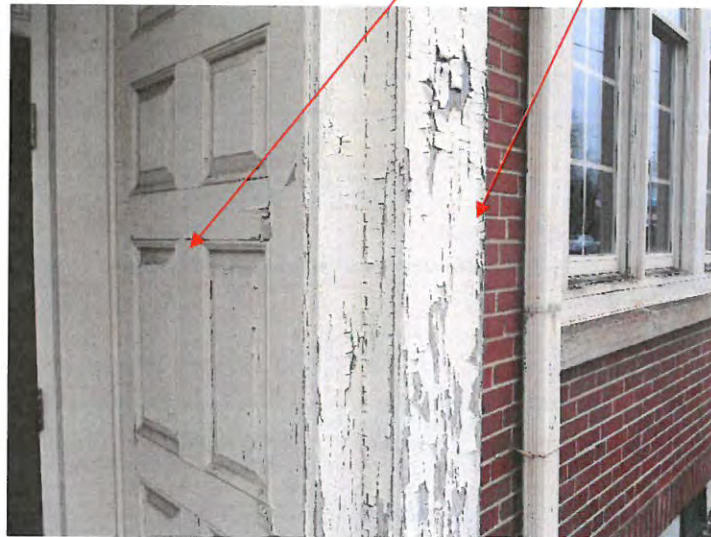
The Inner Wall and the Front Casing of the Front Entrance Alcove was found to utilize Lead-Based Paint

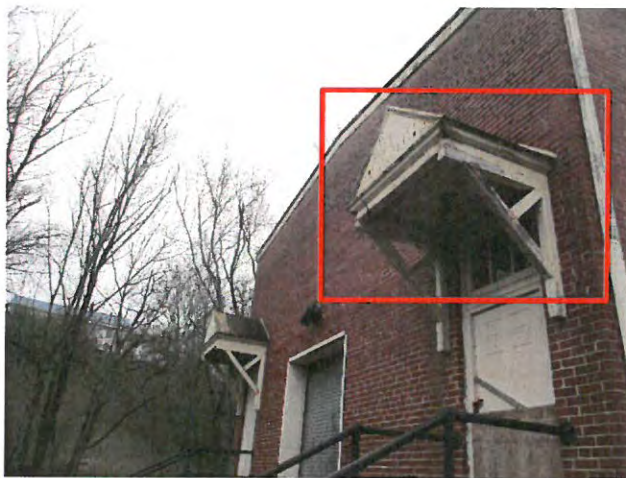
The Wooden Soffit and Fascia Components were found to utilize Lead-Based Paint

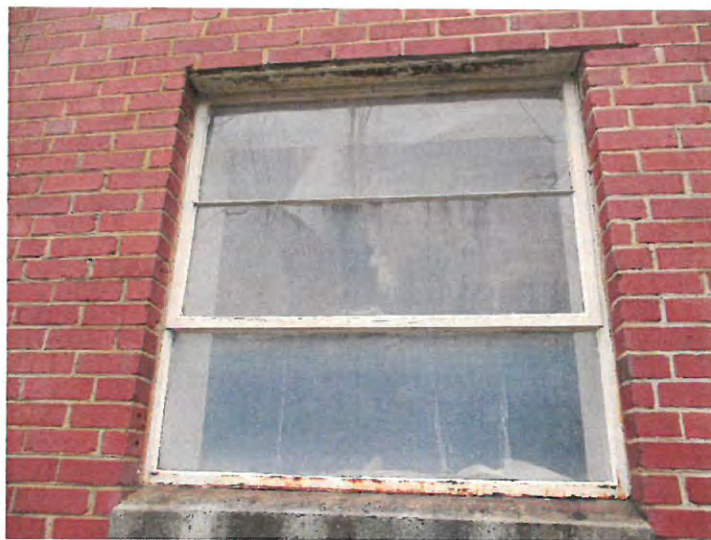
The metal-framed windows were found to utilize Lead-Based Paint
