December 22, 2021

Asbestos & Lead Inspection Report

5305 Hollins Road
Roanoke, Virginia

Roanoke County General Services
Roanoke, VA

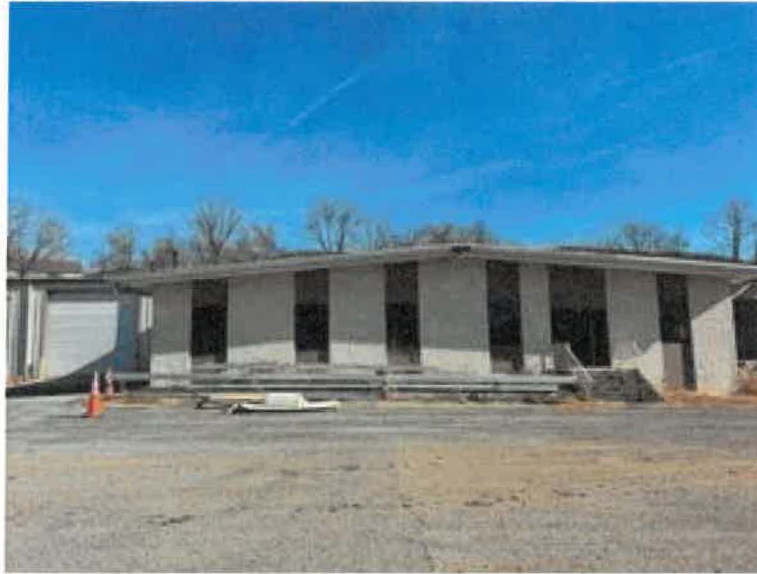
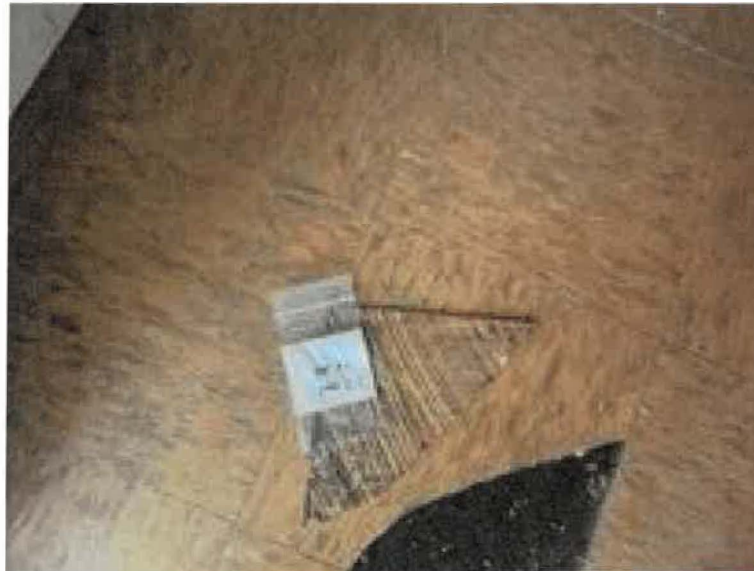
- **All Floor Tile and Associated Mastic in Office Area – *Excluding* Gray Floor Tile at Customer Entrance and Black Floor Tile in Storage Room**
- **Window and Door Framing Caulk – *Excluding* South Entrance**

All Floor Tile and Associated Mastic (Excluding gray floor tile in customer entrance and black floor tile in storage area) was found to be asbestos containing by the laboratory.

These NON-Friable asbestos containing materials should be removed prior to renovation activities at this location, if they are to be disturbed. Removal should be performed by licensed, contract personnel using approved methods.

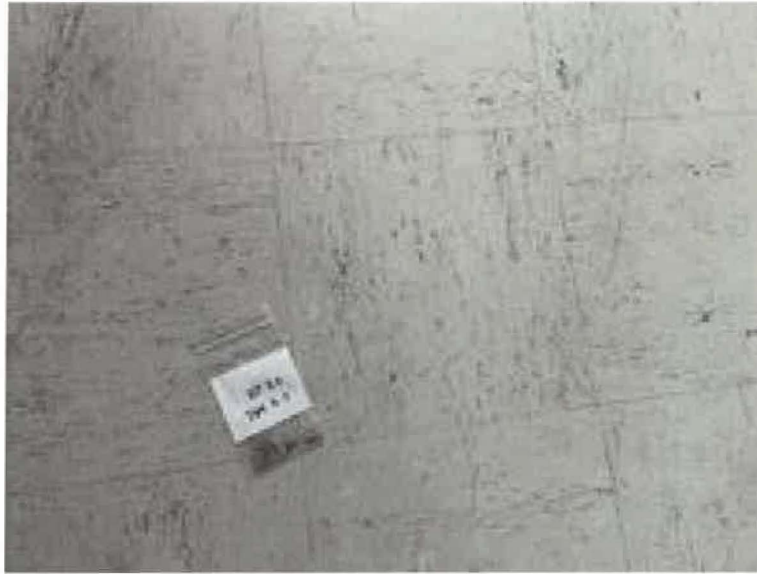
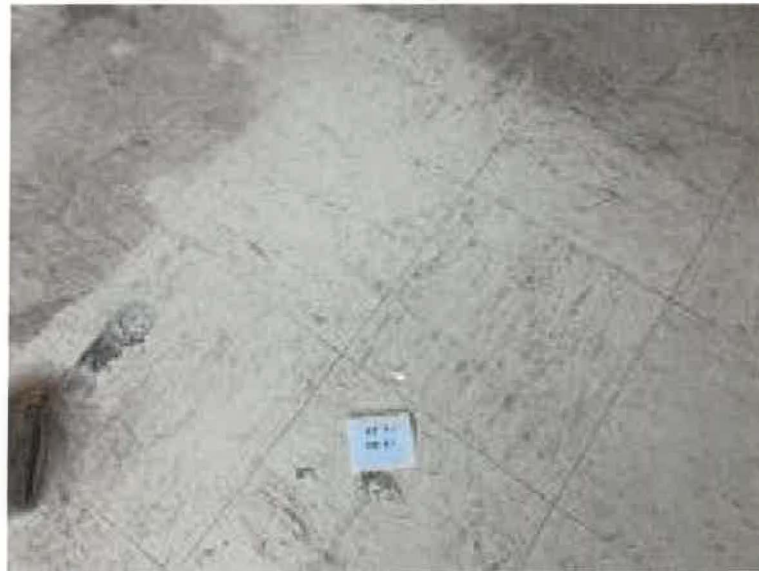
All Floor Tile and Associated Mastic (Excluding gray floor tile in customer entrance and black floor tile in storage area) was found to be asbestos containing by the laboratory.

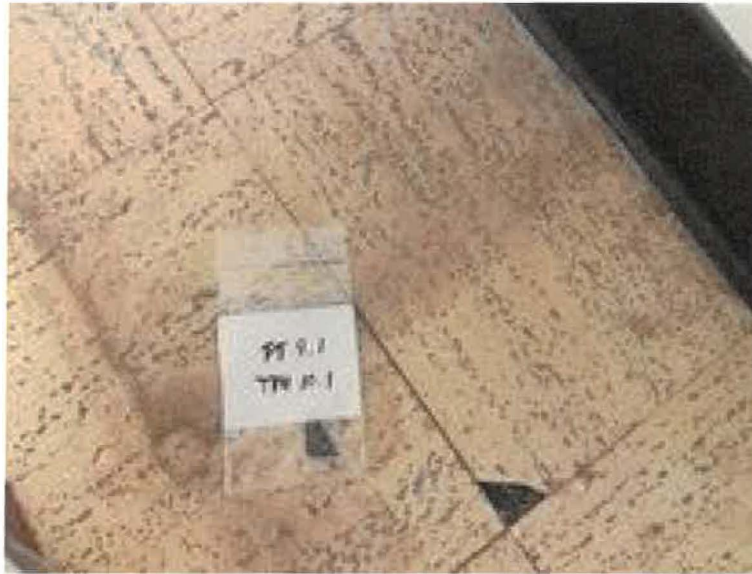
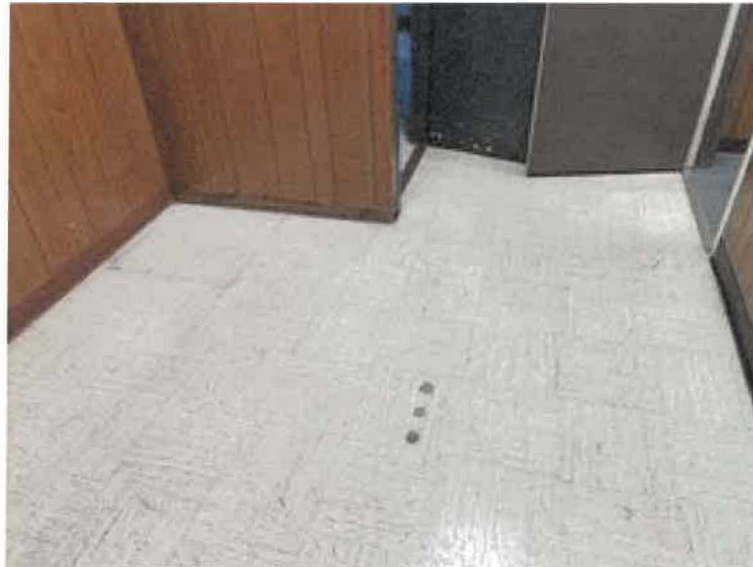
All Floor Tile and Associated Mastic (Excluding gray floor tile in customer entrance and black floor tile in storage area) was found to be asbestos containing by the laboratory.

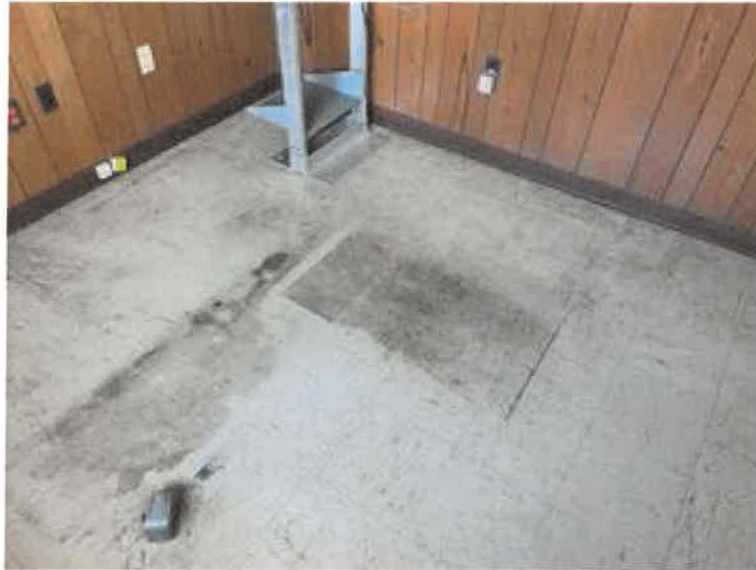
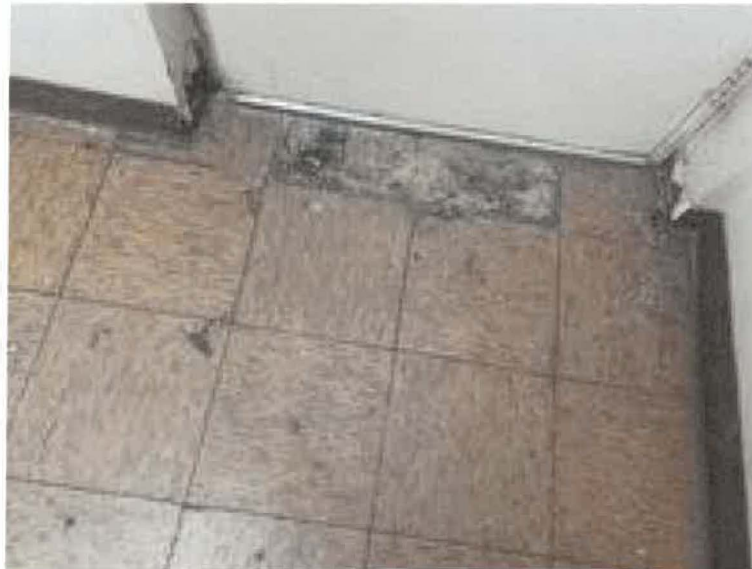
All Floor Tile and Associated Mastic (Excluding gray floor tile in customer entrance and black floor tile in storage area) was found to be asbestos containing by the laboratory.

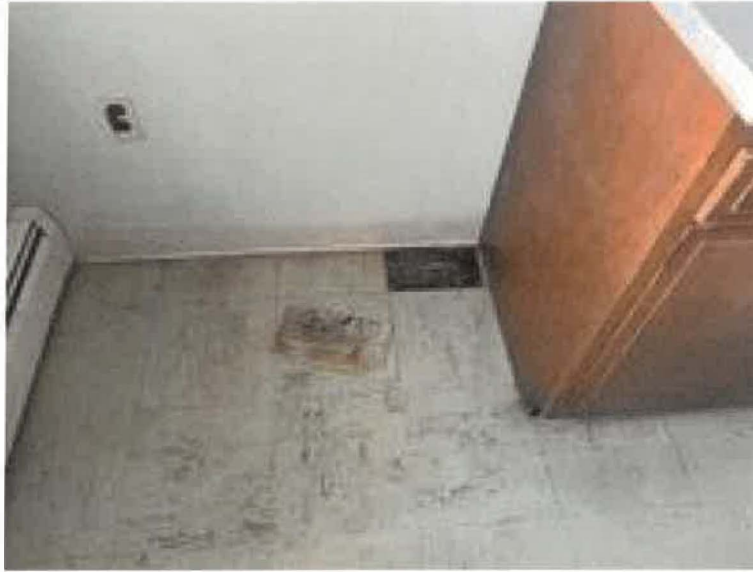
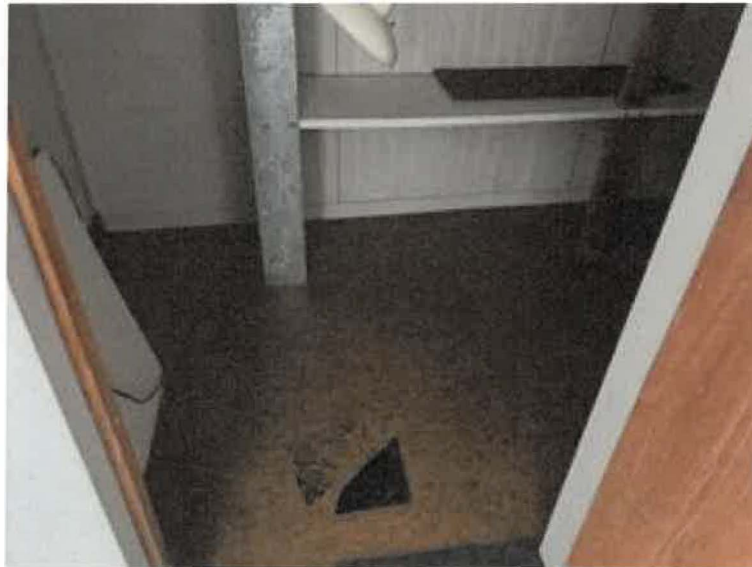
All Floor Tile and Associated Mastic (Excluding gray floor tile in customer entrance and black floor tile in storage area) was found to be asbestos containing by the laboratory.

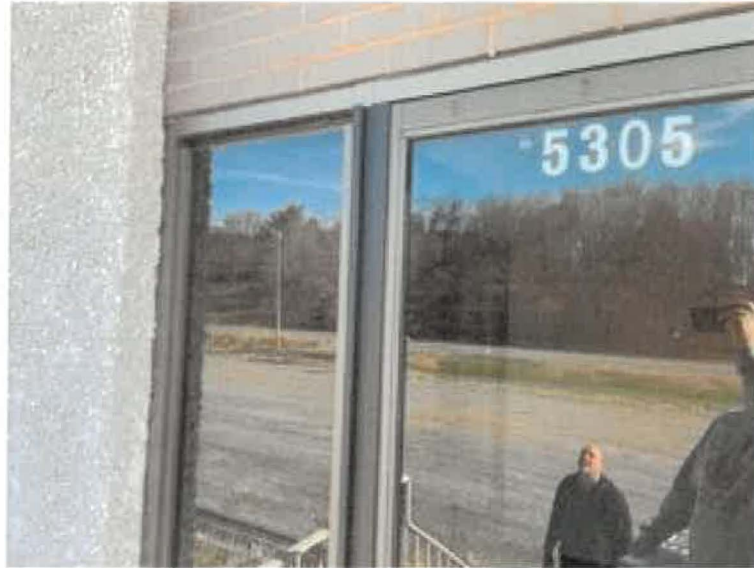
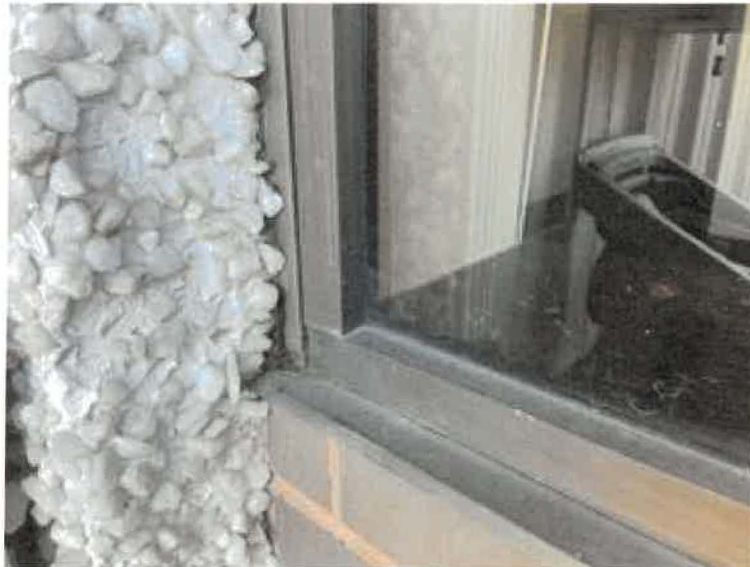
Window and Door Framing Caulk were found to be asbestos containing by the laboratory.

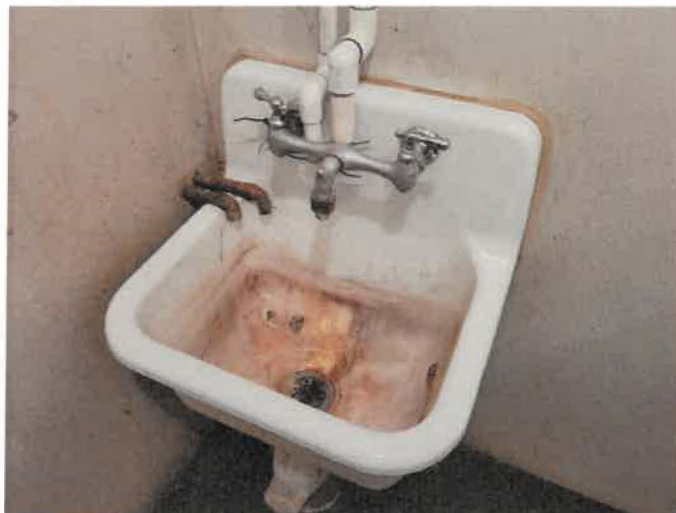
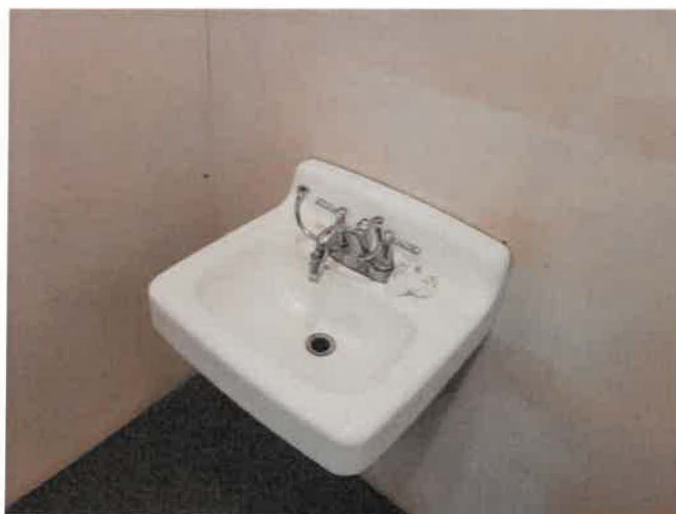
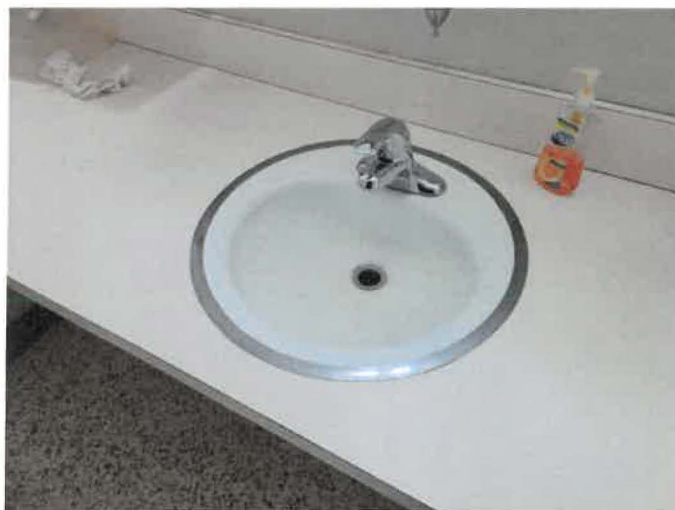
- **Painted Steel Sinks**

For informational purposes, the painted metal sinks were sampled and identified to be lead components. Although not included in the Virginia Lead-based Paint Activities Regulations, the contractor should be provided this information in the event these items are removed for disposal purposes.

If lead is present, regardless of quantity, OSHA regulations are applicable. All persons involved in the disturbance of lead based or lead containing painted surfaces should be adequately trained to do so. All contractors should be provided with the results for their use in meeting current OSHA requirements for the protection of their workers and the environment.
